# DEDICATED TO SAFETY AND SERVICE

2023 DAMAGES REPORT

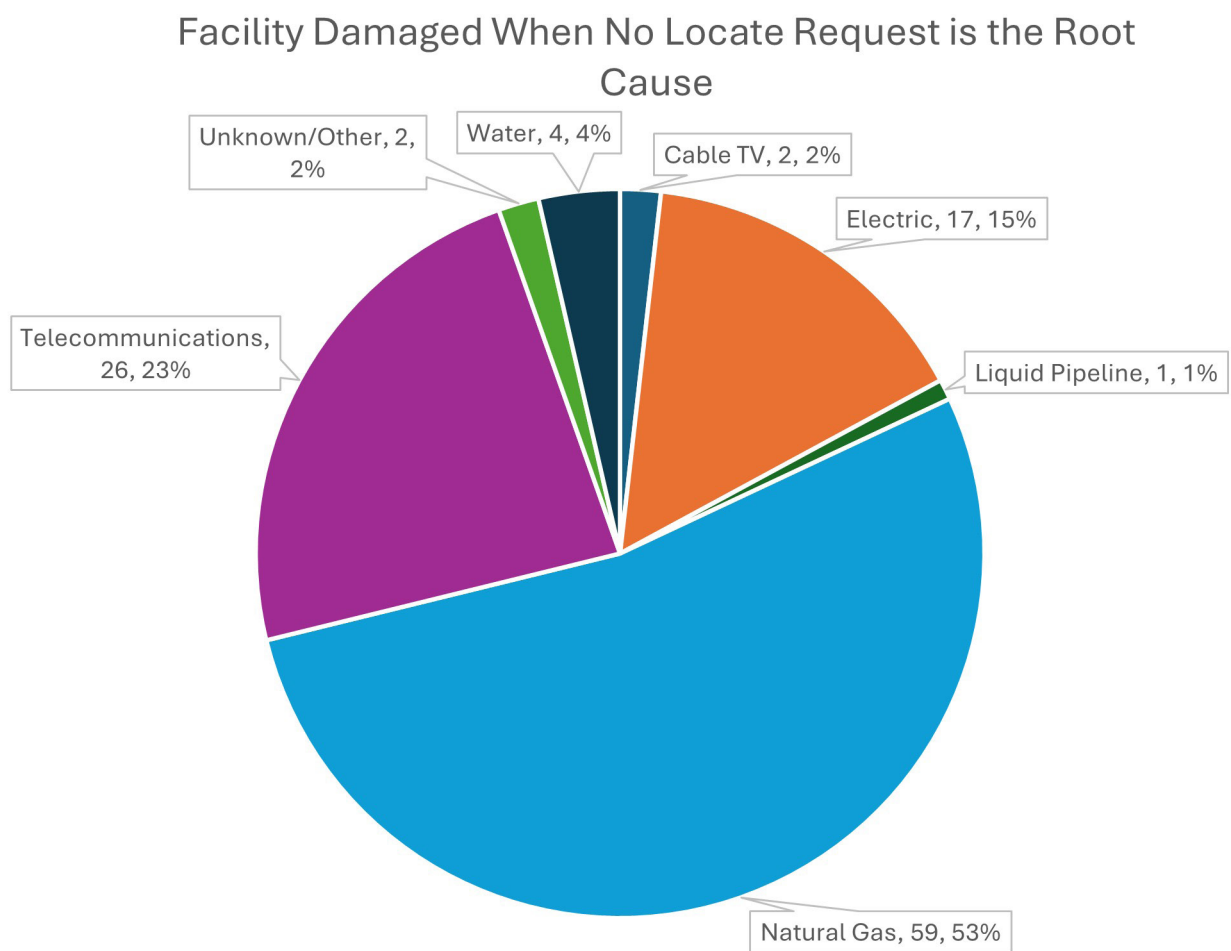
# Facility Damaged When No Locate Request is the Root Cause

When “Failure to make an excavation locate request” is the damage root cause, Natural Gas lines account for half of the damages.

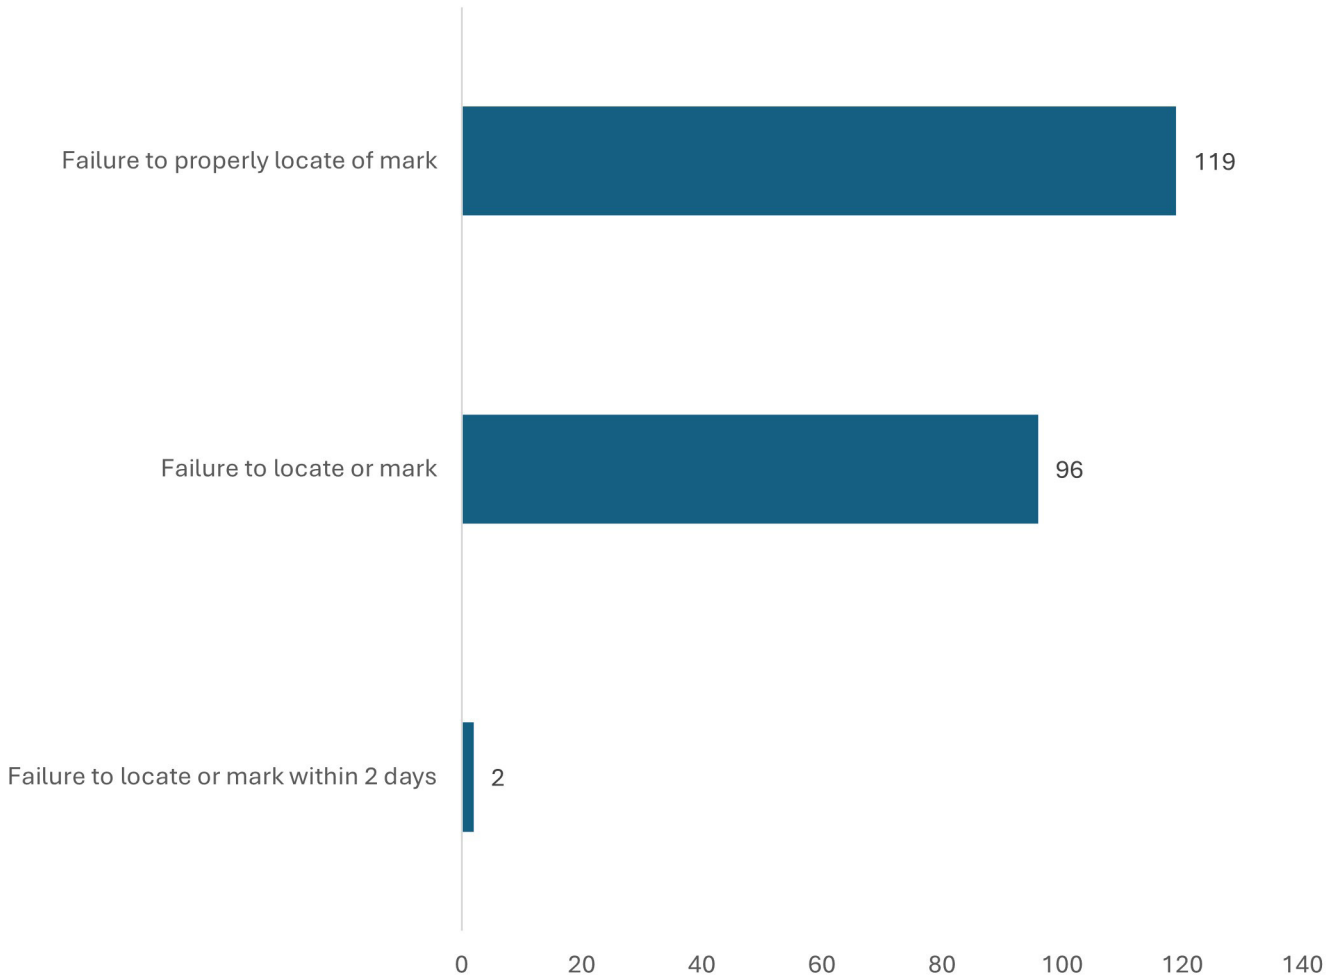
### Locating - Root Causes

The locating practices that account for the majority of locating damages are “Failure to properly locate and mark” and “Failure to locate or mark”.

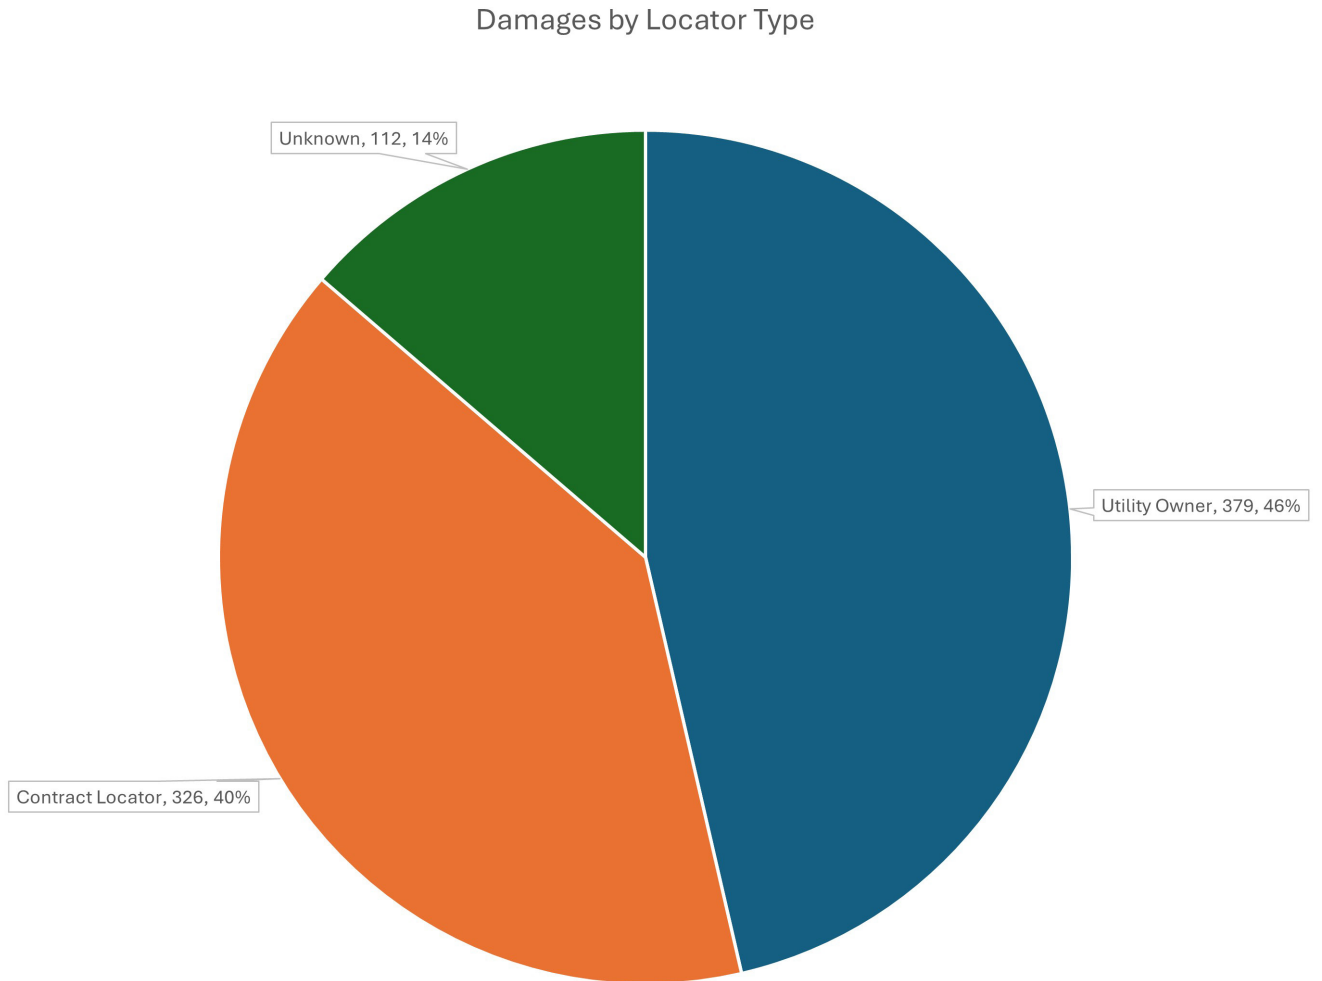
# Damages by Locator Type

Of the known locator type for the actual damages; contract locators account for 326 damages while utility locators account for 379 damages.

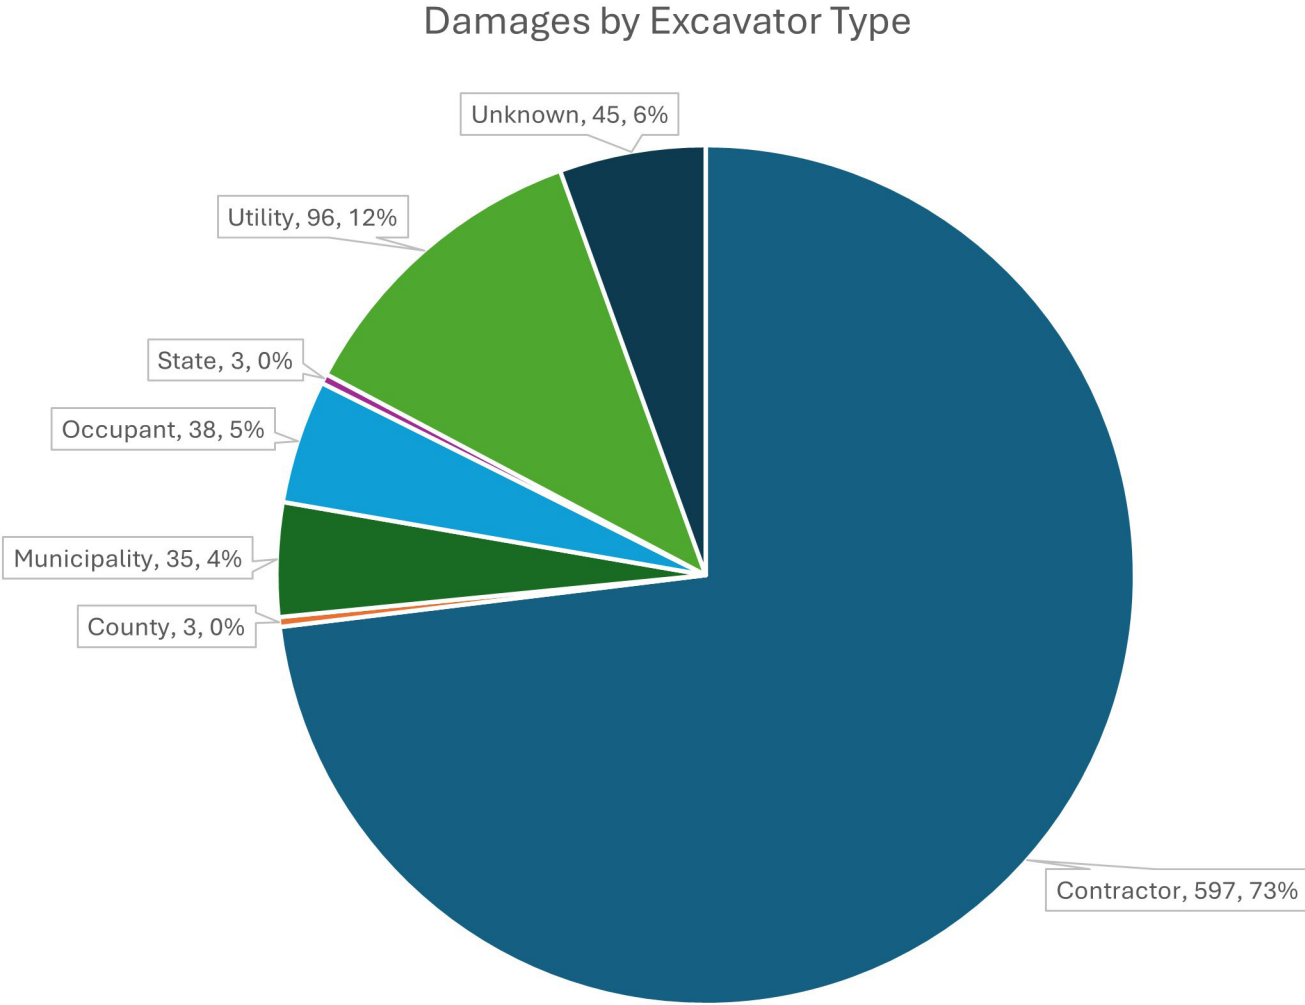
# Damages by Excavator Type

The excavator type with most damages is the "Contractor" category.
